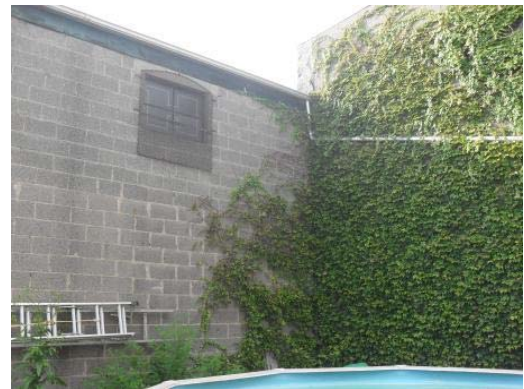
- 1. **Walks:** Concrete /Cracked, Tripping hazard, Concrete pitted and chipped
- 2. **Retaining Walls:** Block 1. Seal cracks to avoid further damage,
Refer to retaining wall at the left hand side of the building (loading docks)
- 3. **Vegetation:** Grass, Trees, and Bushes /Tree limbs over hang the roof and should be cut back. Refer to the rear wall at the building on Chadwick St /Remove vine off bearing wall at rear part of the building.

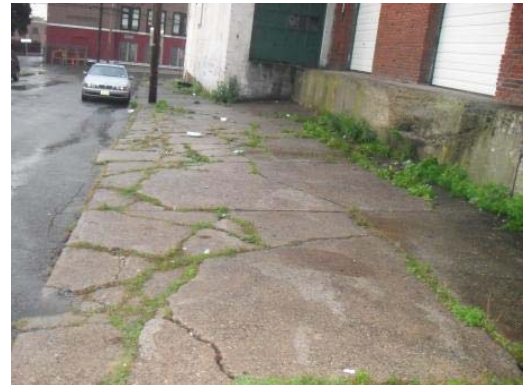
- 4. **Basement Stairwell:**
- 5. **Grading:** Minor slope Recommend the addition of fill dirt to improve grade
- 6. **Window Wells:** None
- 7. **Basement Stairwell Drain:**
- 8. **Exterior Surface Drain:**
- 9. **Driveway:** Concrete /driveway needs to be paved. Refer to loading docks area at Braun St

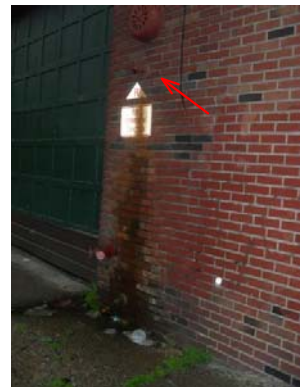
- 10. **Fences:** n/a
- 11. **Fire Sprinklers:** Beyond the scope of the inspection Not part of the inspection's scope. However, active leak noticed

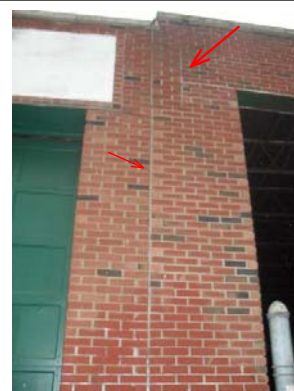
Front Face of Building on Marshall Exterior Surface

1. **Type:** Brick veneer Stress cracks, gaps of about 3/8" noticed. Consult a structural engineer prior to closing

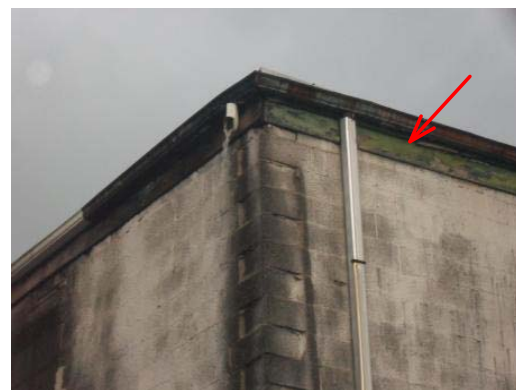
3. **Fascia:** Wood Fascia is being wood water exposed all around the building. Wood rot noticed. Active water damages.

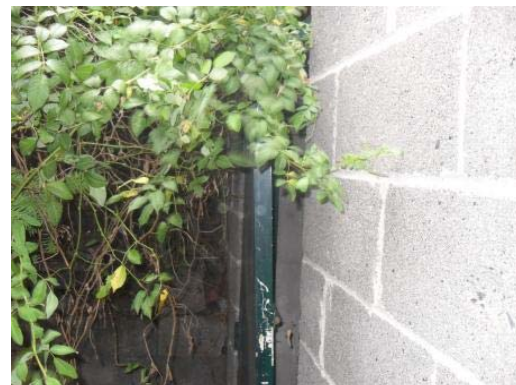
8. **Exterior Exit door:** Needs to be repaired /Door not closing at all. Refer to door at the rear part of the building, located on Chadwick St. Remove branches from the entrance door.

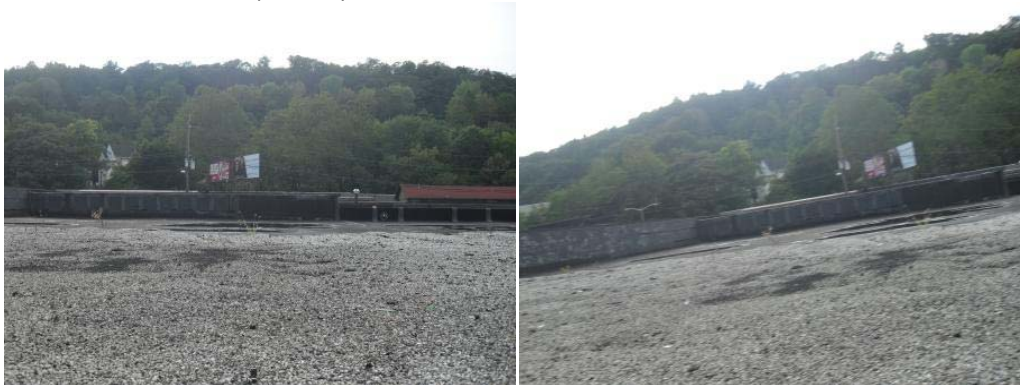
Main Roof Surface

2. **Material:** Appears to be Modified Bitumen 1. Roof shows major deterioration. The roof was covered with some gravel. No maintenance appears to be done in years. Water puddles noticed at different spots of the roof. Also, when observed from inside the building, active water filtration was noticed and many areas of the ceiling were damaged
2. The roof needs to be replaced by a roof contractor.

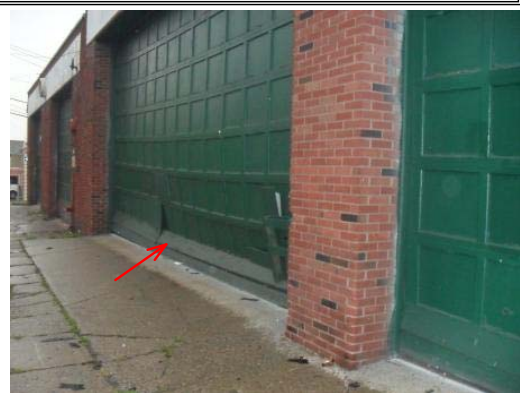
2. **Loading docks Doors:** Wood Door panels need to be replaced. Opening mechanism not functional for most of the doors. Door guides missing, missing rollers and operating hardware.

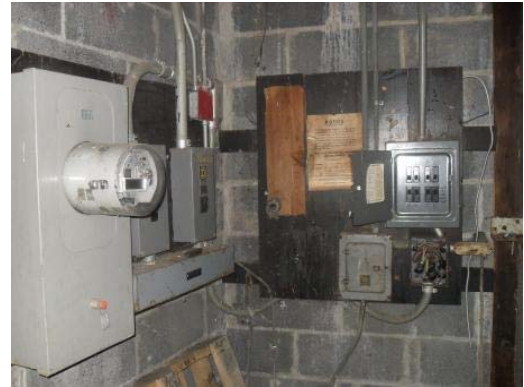
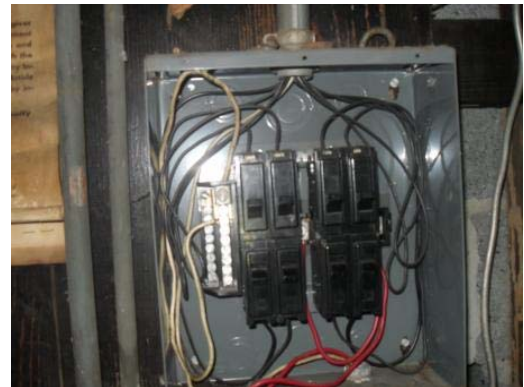
Main building / 2 panels Electric Panel _____

5. **Manufacturer:** Square D 1. THE ELECTRICAL SYSTEM at this entire building must be re-inspected by a certified electrician. each panel must be label so the different zones are properly identified PRIOR to occupancy.
2. Current panels need to be upgraded

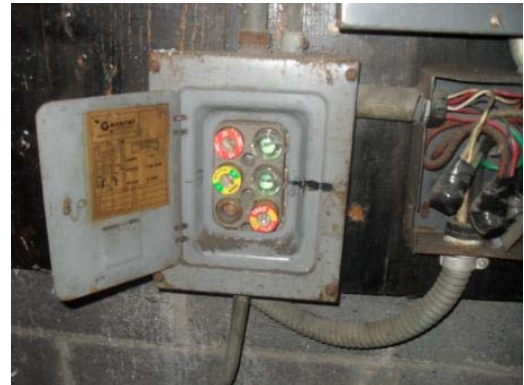
8. **Breakers:** Copper #0 available slots noticed at the panel for future electrical circuits
9. **Fuses:** Screw type Improper fuse size for circuit- requires correction, Loose fuses- properly resecure. Missing fuses

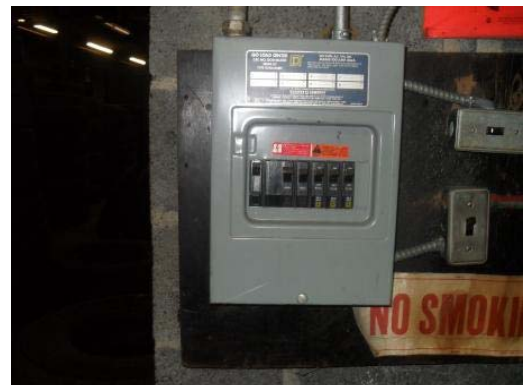
11. **Manufacturer:** Square D
12. **Maximum Capacity:** No single main breaker exists

13. **Main Breaker Size:** 20 Amp Evaluation by a licensed electrician is recommended.
Tight access to the panel
14. **Fuses:**

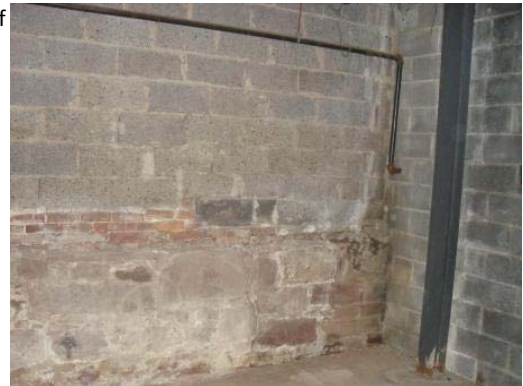
1. **Structure Type:** Masonry
2. **Foundation:** Stone /Foundation wall at the Chadwick building settled. A row of bricks over the stone foundation settled as well causing steps cracks on the concrete wall. Repairs needed to avoid further damages.
/An engineer MUST provide repair estimates prior to closing

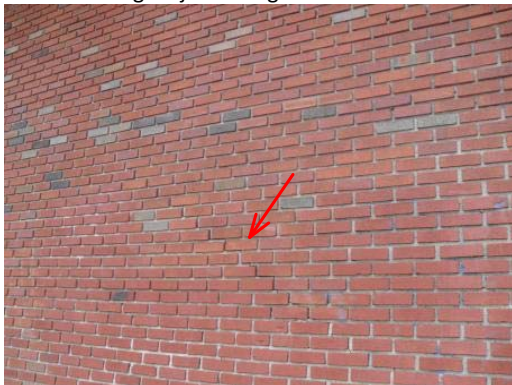
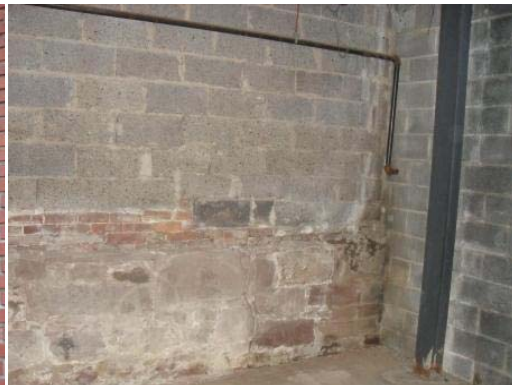
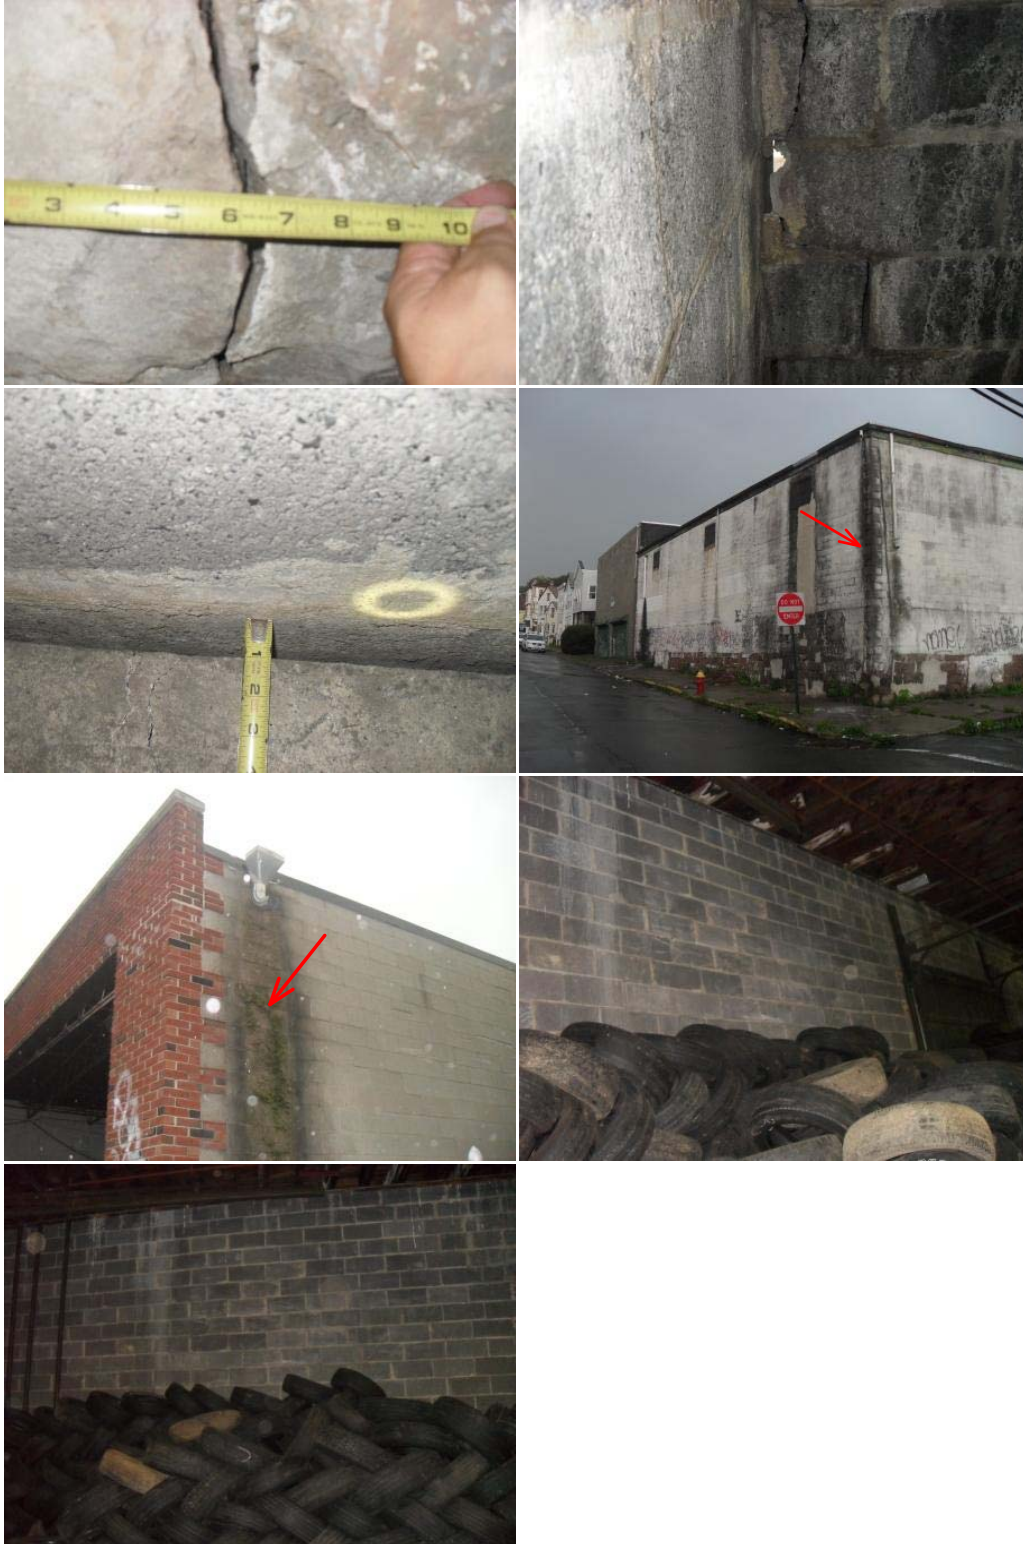
3. **Differential Movement:** No movement or displacement noted
4. **Beams:** Concealed
5. **Bearing Walls:** Brick 1. Front face, on Marshall St.,: Bearing wall has vertical cracks and will require evaluation and repairs PRIOR to occupancy.

2. Bearing wall parallel to Braun St: Concrete wall buckled outwards about 1" inch. Major crack going through out the entire wall from top to bottom noticed. The inspector was able to see light through and the gap ranges from 3/4"-1". Floor settlement at this specific area was noticed as well. About 3" off from floor building level. Inspection of this bearing wall was also done from outside the building. Standing at the corner of Braun St and Chadwick St., the inspector noticed water off the roof was being discharge all along the wall. Major cracks. Wall could collapse at any time. As it was mentioned to the buyers, a structural engineer must evaluate not only the ENTIRE BEARING WALL around the building, but some columns affected by floor settlement.

3. Brick wall at the corner of Braun St and Marshall St., presented step cracks.
4. Concrete block wall at the area where the spare tires are located: Step cracks noticed. The spare tires are providing a horizontal load to the wall. The tires did not allow the inspector to observe the entire wall. Tires MUST be remove. The entire wall must be repaired prior to occupancy.

6. Bearing wall at the right hand side of the building when standing on Marshall St., presented step cracks. Water discharge off the roof is causing major damages as well.

5. A structural engineer MUST evaluate all areas mentioned to the buyers at the time of the inspection. Buyer took additional pictures of the areas matter of concern. Major repairs must be done to assure the building is SAFE and structurally sound PRIOR to occupancy.

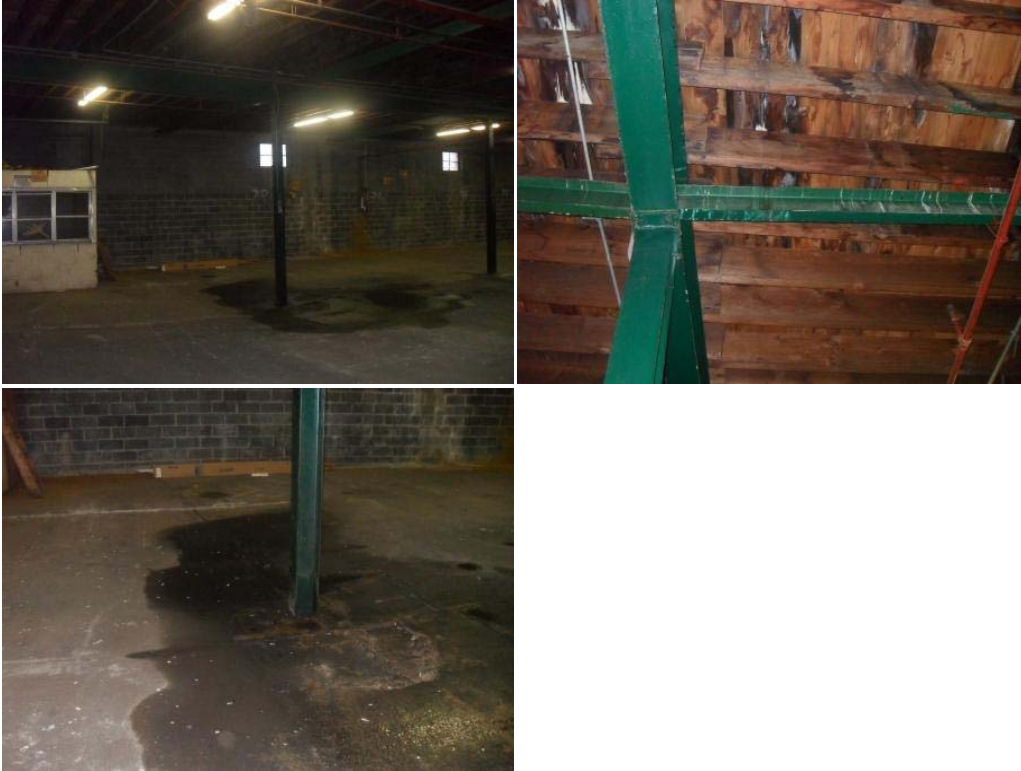
6. **Piers/Posts:** Steel posts /Steel column sunk due to floor settlement. Concrete floor cracked and settled about 3" from level. Truss beam supporting the roof lost proper pitch and alignment. A structural engineer MUST re-inspect, evaluate and estimate cost repairs PRIOR to closing.

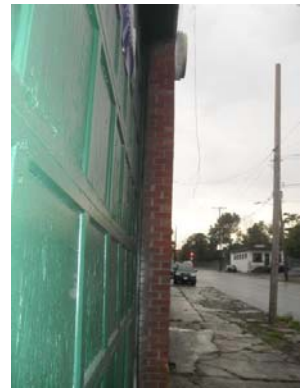
7. **Piers/Posts:** brick piers Brick columns at the front face of the building presented a variable gap from top to bottom. Columns were shifted outwards. A structural engineer MUST re-inspect, evaluate and estimate cost repairs PRIOR to closing.

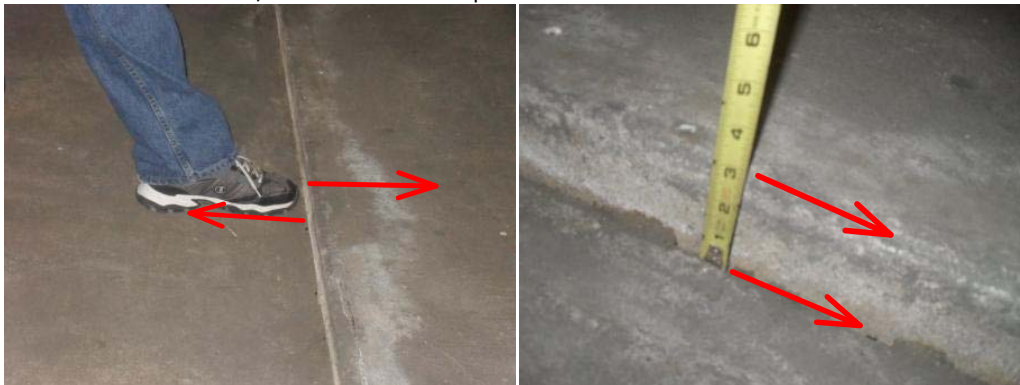
11. **Floor/Slab:** Poured slab /Settlement at some spots about 3" off level

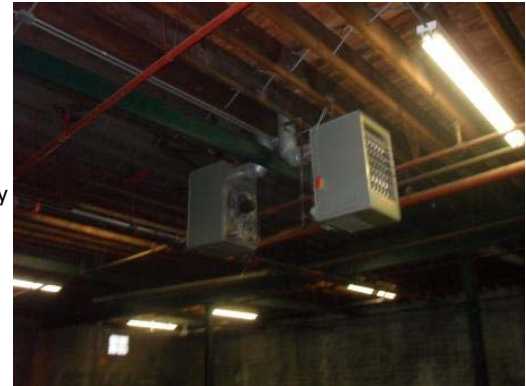
Main Heating System

1. **Heating System Operation:** Not inspected /No gas available during inspection. Not inspected as it was mentioned to the buyers.
NOTES:
1. Inspector cannot determine how long this unit will last since this is a VISUAL inspection not a mechanical inspection
2. Unit could last 21-22 years based upon manufacturer and service provided
3. It is recommended to sign up for a worry free service at your local gas or utility service provider.
4. Cleaning/ maintenance recommended PRIOR to occupancy, ALL heating and cooling system needs to be operated and tested prior to closing, at the time of the walk through. It could malfunction between the inspection and closing period.
