CHECKMARK PLUS, INC.

Home Inspection / (1) Family

Report # SAMPLE

STREET ADDRESS
TOWN, NJ ZIP CODE

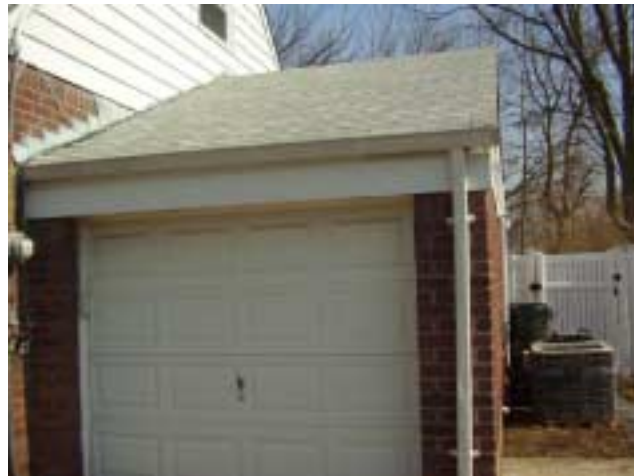
1. **Type of Structure:** Attached **Car Spaces:** 1

- 2. **Garage Doors:** Fair Remove personal items from garage prior to closing
- 3. **Door Operation:** Mechanized
- 4. **Door Opener:** Lift Master 1. Code to open garage door from outside was Inoperative at time of inspection,
 - 2. Buyer to request a remote garage opener from the seller prior to closing,
 - 3. Safety reverse system in operation,
 - 4. Light beam safety is recommended
- 5. **Exterior Surface:** Fair
- 6. **Roof:** Asphalt shingle
- 7. **Roof Structure:** Rafter
- 8. **Service Doors:** Fair
- 9. **Ceiling:** Fair condition
- 10. **Walls:** Fair
- 11. **Floor/Foundation:** Fair condition
- 12. **Electrical:** 110 VAC outlets and lighting circuits
- 13.
- 14. **Heating:**
- 15. **Windows:**

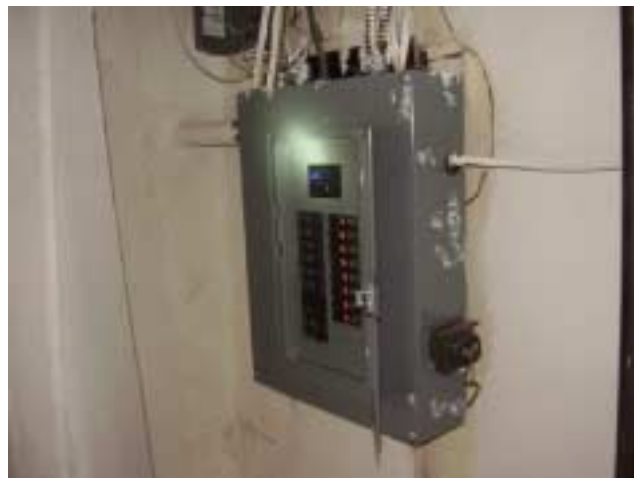
Basement Electric Panel

5. **Manufacturer:** Seimens

6. **Maximum Capacity:** 100 Amps
7. **Main Breaker Size:** 100 Amps
8. **Breakers:** Copper and Aluminum
9. **Fuses:**
10. **GFCI:** At GFCI receptacles only

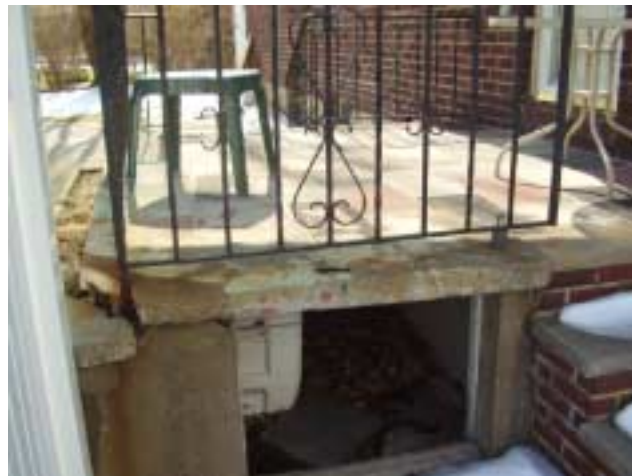
Rear part of the property Crawl Space

1. **Method of Inspection:** From the access

- 2. **Unable to Inspect:** 15% Access partially blocked
- 3. **Access:** fair
- 4. **Moisture Penetration:** No moisture present at time of inspection
- 5. **Moisture Barrier:**
- 6. **Ventilation:** Open at both ends
- 7. **Insulation:**
- 8. **Vapor Barrier:**
- 9. **Sump Pump:**
- 10. **Electrical:**
- 11. **HVAC Source:**

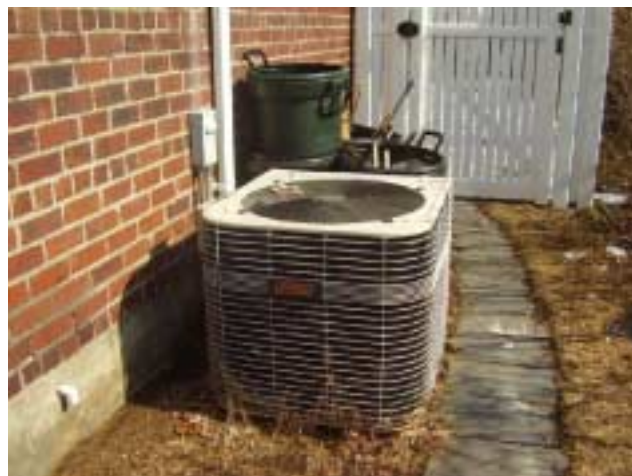
Main AC System

- 1. **A/C System Operation:** Not inspected To avoid possible compressor damage due to outside temperature below 60 degrees, the unit was not tested.
AC vents at the second floor are located on the surface floor. It is not the most functional spot.
- 2. **Condensate Removal:** PVC
- 3. **Exterior Unit:** Fair

4. **Manufacturer:** Lennox

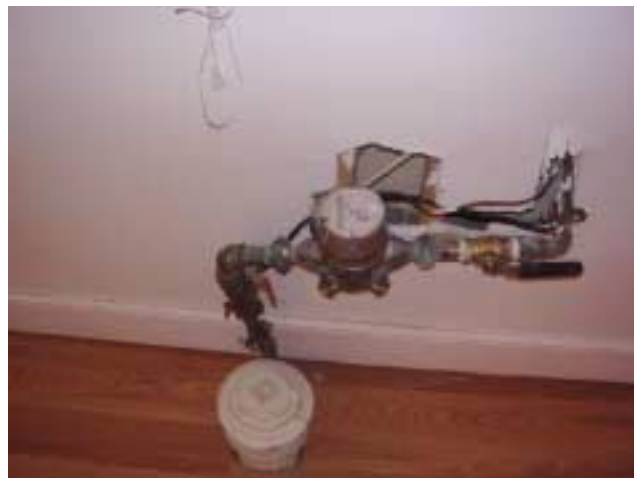
- 1. **Service Line:** Concealed
- 2. **Main Water Shutoff:** Basement

- 3. **Water Lines:** Copper
- 4. **Drain Pipes:** Cast iron
- 5. **Service Caps:** Concealed
- 6. **Vent Pipes:** Cast iron
- 7. **Gas Service Lines:** Insulflex

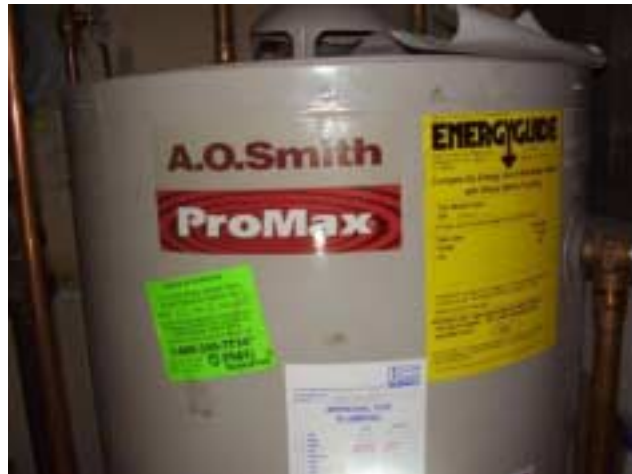
Basement/utility room Water Heater

8. **Water Heater Operation:** Functional at time of inspection
 Draining the water heater at least twice a year is recommended to relieve sediment build up in the tank.
 Follow the manufacturer's service and maintenance instructions

9. **Manufacturer:** A.O. Smith
 10. **Type:** Natural gas **Capacity:** 40 Gal.
 11. **Approximate Age:** 1 Year **Area Served:** Whole building
 12. **TPRV and Drain Tube:** Copper

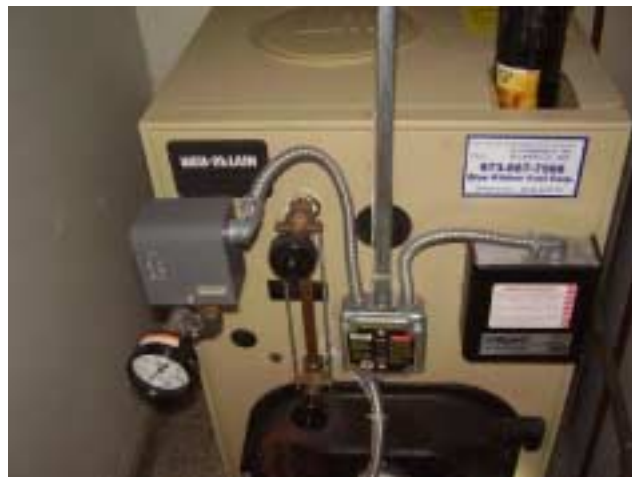
Basement Heating System

1. **Heating System Operation:** Appears functional Inspector cannot determine how long this unit will last since this is a VISUAL inspection not a mechanical inspection

2. **Model Number:** Weil McLain **Serial Number:** not recorded
 3. **Type:** Oil steam boiler system **Capacity:** Not recorded
 4. **Area Served:** 1st and 2nd floor **Approximate Age:** Unknown
 5. **Fuel Type:** Oil
 6. **Distribution:** Radiator The radiators may leak after the system is functional for a reasonable period of time. The radiator may need service and maintenance after the system has been turned on for a reasonable period of time.
 7. **Circulator:** Gravity
 8. **Devices:** Expansion tank
 9. **Humidifier:**
 10. **Thermostats:** Individual

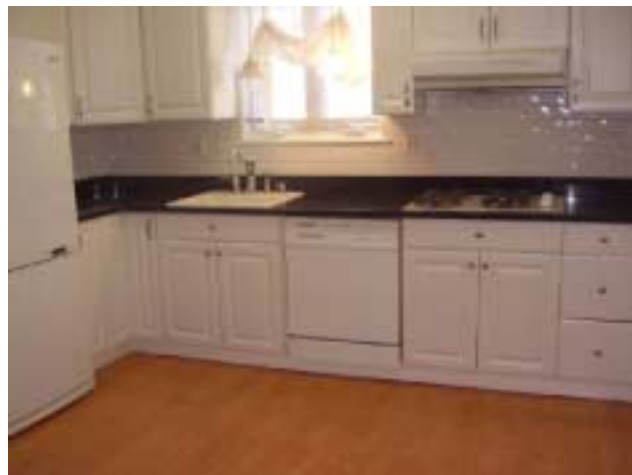
1st Floor Kitchen

- 1. **Cooking Appliances:** Fair Inspection of appliances are NOT part of the scope of the Home Inspection.

- 2. **Ventilator:** Fair
- 3. **Disposal:** n/a
- 4. **Dishwasher:**
- 5. **Air Gap Present?** Yes No
- 6. **Trash Compactor:**
- 7. **Refrigerator:** Fair
- 8. **Microwave:** N/A
- 9. **Sink:** Fair
- 10. **Electrical:** 110 VAC GFCI Faulty GFCI outlet-replace
- 11. **Plumbing/Fixtures:** Fair
- 12. **Counter Tops:** Fair
- 13. **Cabinets:** Wood
- 14.

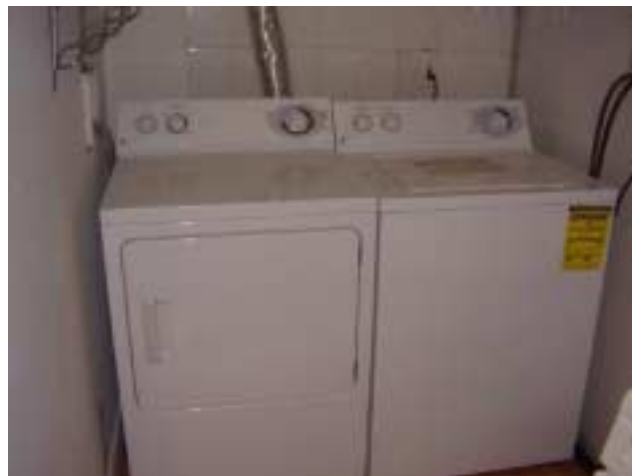
Basement Laundry Room/Area

- 1. **Closet:** None

- 2. **Ceiling:** Fair
- 3. **Walls:** Fair
- 4. **Floor:** Fair
- 5. **Doors:** Fair
- 6. **Windows:** Fair
- 7. **Electrical:** 110 VAC outlets and lighting circuits
- 8. **Smoke Detector:** These are part of the Certificate of Occupancy
- 9. **HVAC Source:** No heat
- 10. **Laundry Tub:**
