Property Inspection Report

Sample Insp Report 082020.inspx

TYPE-PROPERTY ADDRESS INSPECTED
CITY, STATE ZIP CODE

Checkmark Plus, Inc
49 Market St.
Saddle Brook, NJ 07663
Inspected by:
Herman Andrade
NJIT Mechanical Engineer

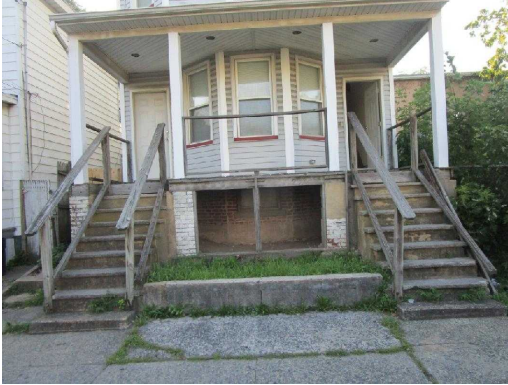
6. ☐☐☐☐☒ Porch: Open porch /main entrance - NOTICED: /Main entrance porch is not structurally sound
ACTION: / repair PRIOR to limitation set forth by the contract.

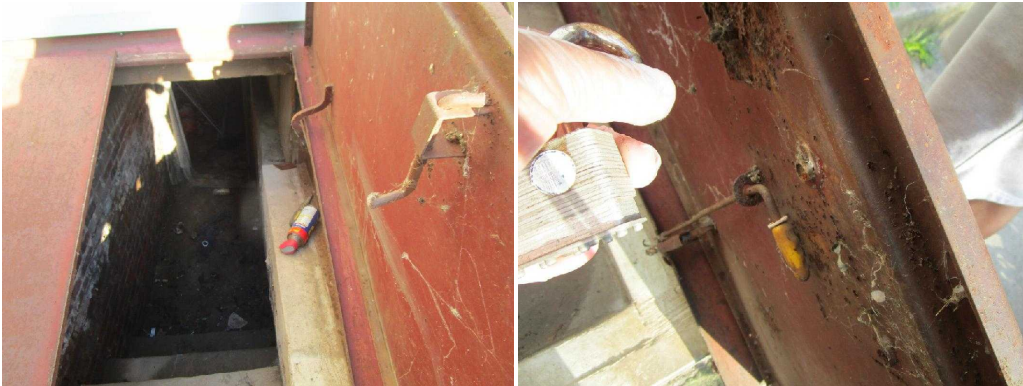
8. ☐☐☐☐☒ Basement Stairwell: Repair prior to occupancy - NOTICED: /1. Rusted metal bilco door. /2. Hardware issues.
ACTION: /Install a new door PRIOR to limitation set forth by the contract.

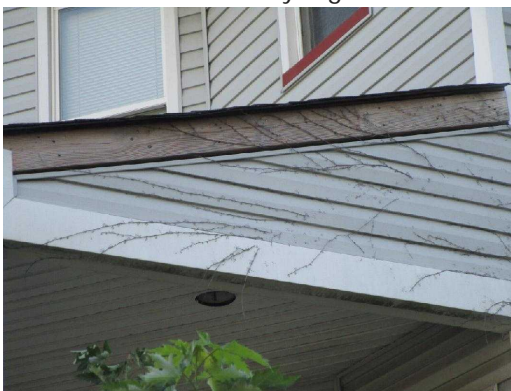
6. Trim: Wood - NOTICED: /1. Trim to be done. /2. Missing aluminum. /3. Exposed exterior rafters.
ACTION: /Evaluation by a general contractor is a must PRIOR to limitation set forth by the contract.

ACTION: /Evaluation by a general contractor is a must PRIOR to limitation set forth by the contract.

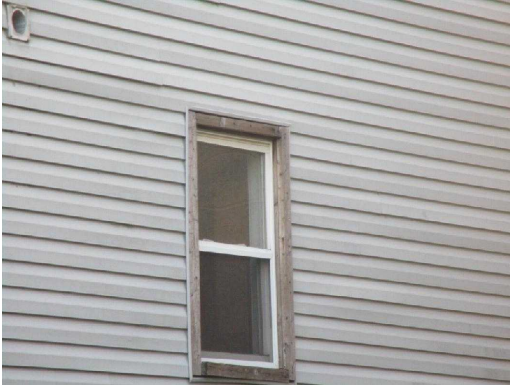
6. ☐☐☐☐☒ Windows: Repair prior to closing - NOTICED: /1. Missing aluminum capping at some window framing. /2. Seal and caulk to avoid water filtration behind the siding.
ACTION: /1. Seller to re-inspect and repair ALL windows prior to walk through. /2. ALL windows must lock and operate properly. ALL window screens must be in place. /3. Buyer to re-inspect at walk through.

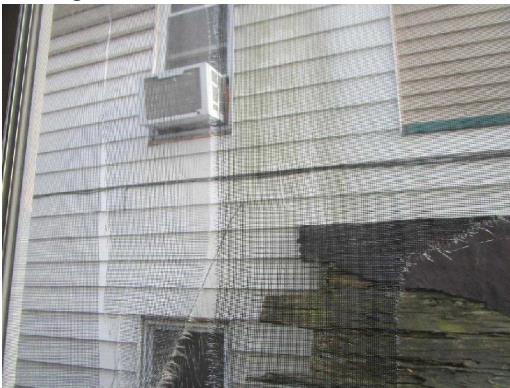
7. ☐☐☐☐☒ Window Screens: Wire mesh - NOTICED: /1. Some window screens were missing. /2. Some window screens were damaged.
ACTION: /1. Seller to re-inspect and repair ALL windows prior to walk through. /2. ALL windows must lock and operate properly. ALL window screens must be in place. /3. Buyer to re-inspect at walk through.

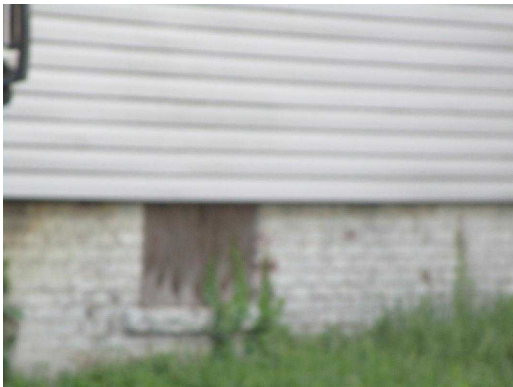
Basement Windows: (continued)

8. ☐☐☐☐☒ Basement Windows: Non-opening - NOTICED: /Covered with plywood.
ACTION: /1. Seller to re-inspect and repair ALL windows prior to walk through. /2. ALL windows must lock and operate properly. ALL window screens must be in place. /3. Buyer to re-inspect at walk through.

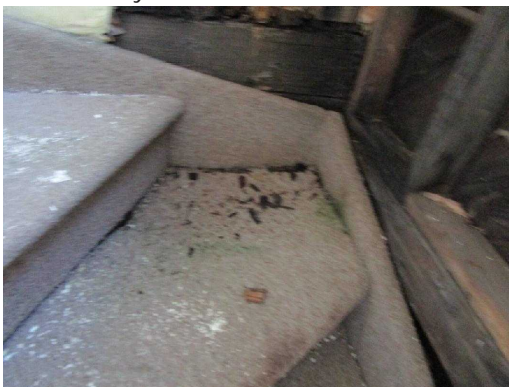
1. ☐ ☐ ☐ ☐ ☒ Stairs/Handrails: Wood Stairs - NOTICED: /1. Missing handrail on staircase. /2. Missing balusters /3. Some steps are NOT sturdy: safety issues
ACTION: /A registered general contractor MUST evaluate and estimate repairs PRIOR to limitation set forth by the contract.

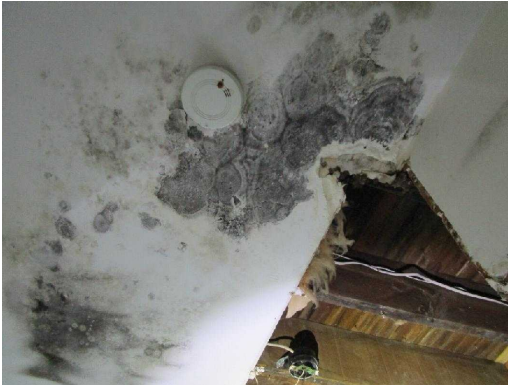
3. ☐☐☐☐☒ Walls: Paint - NOTICED: /1. Major interior water damaged in walls and ceiling. /2. Appears to be mold.
ACTION: /A registered general contractor must repair PRIOR to limitations set forth by the contract.

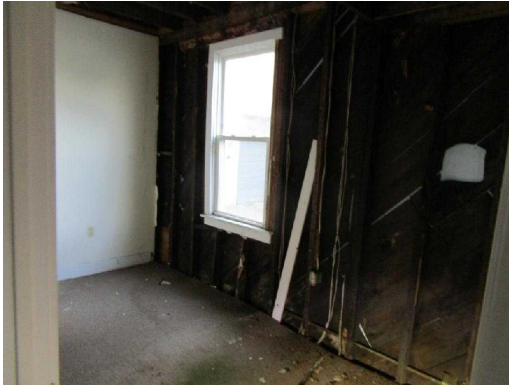
4. ☐☐☐☒ Floors: Carpet - NOTICED: /1. Major carpet floor damages at some bedrooms.
ACTION: /A registered general contractor must repair PRIOR to limitations set forth by the contract.

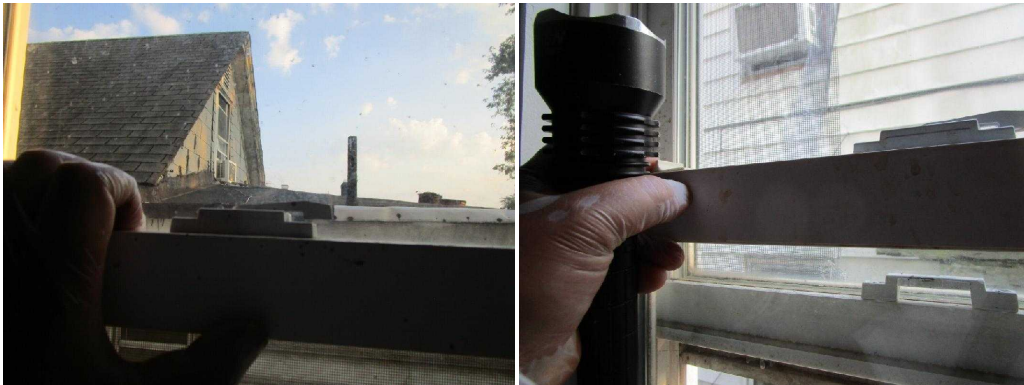
5. ☐☐☒☐ Windows: Vinyl - NOTICED: /Windows with difficult operation.
ACTION: /A registered general contractor must repair PRIOR to limitations set forth by the contract.

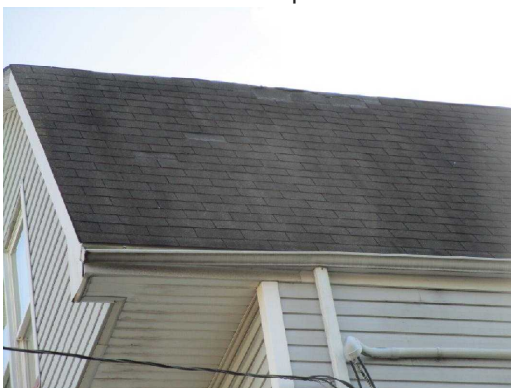
2. ☐☐☐☐☒ Material: Asphalt shingle - NOTICED: /1. Missing , damaged shingles . /2. Hole on the roof. /3. Extensive water damages due to roof leaks.
ACTION: /Roof to be replaced PRIOR to occupancy.

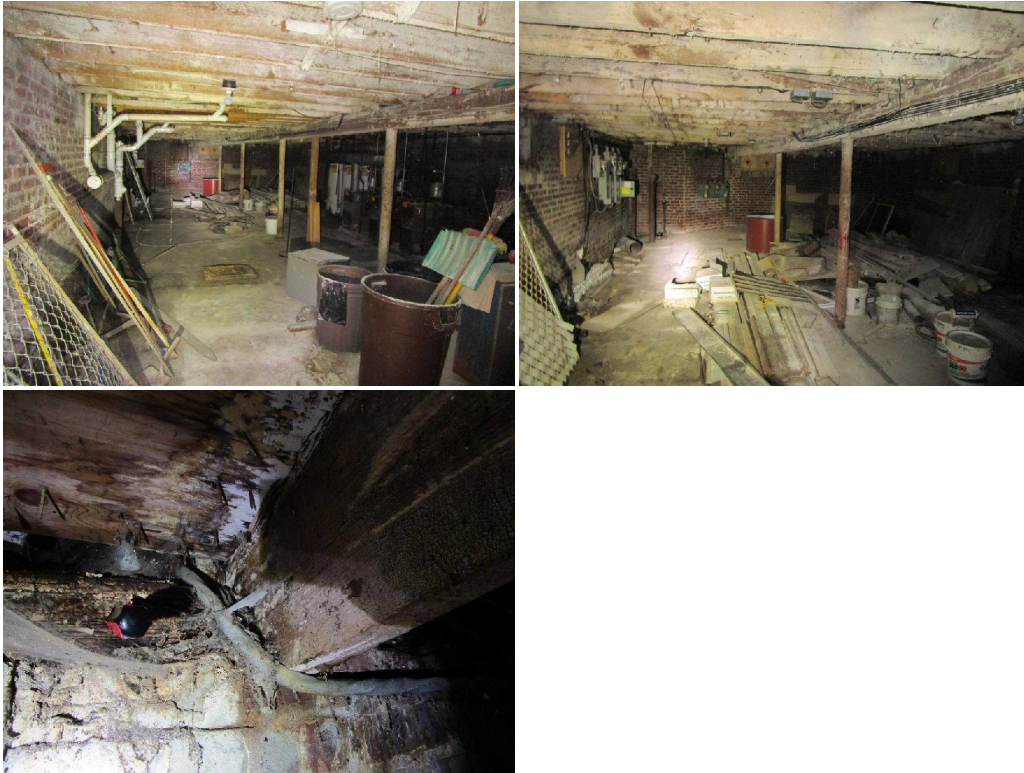
1. ☐☐☐☐☒ Ceiling: Exposed framing - NOTICED: /Termite damaged noticed.
ACTION: /1. A registered general contractor MUST evaluate and estimate repairs PRIOR to limitation set forth by the contract. /2. Termite treatment needed.

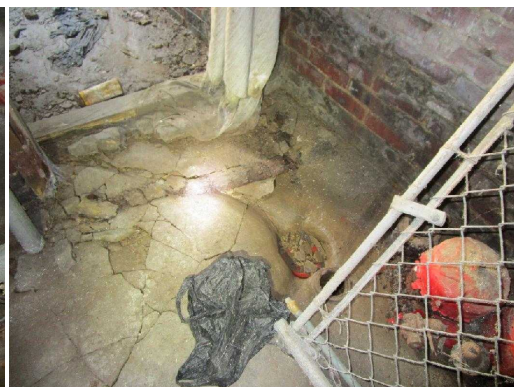
3. ☐☐☐☐☒ Floor: Concrete - NOTICED: /1. High humidity. /2. Water stains noticed. /3. As it was explained to the buyer(s), the inspector cannot warranty there will never be water filtration at all at this basement. Water seepage noticed during inspection. /4. Evidence of water filtration at the basement. /5. Grooves in the floor to guide water to service caps.
ACTION: /A registered general contractor MUST evaluate and estimate repairs PRIOR to limitation set forth by the contract.

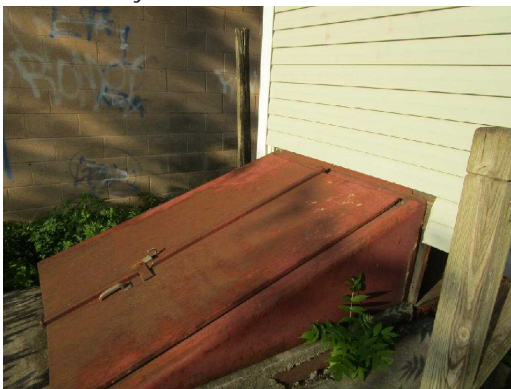
4. ☐☒☐☐☐ Floor Drain: Not noticed
5. ☐☐☐☐☒ Doors: Bilco metal door - NOTICED: /1. Hardware issues. /2. Excessive rust noticed.
ACTION: /A registered general contractor MUST evaluate and estimate repairs PRIOR to limitation set forth by the contract.

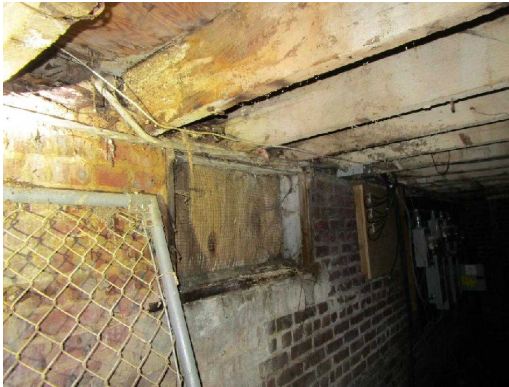
6. ☐☐☐☐☒ Windows: Replace prior to closing - NOTICED: /Covered with plywood.
ACTION: /A registered general contractor MUST evaluate and estimate repairs PRIOR to limitations set forth by the contract.

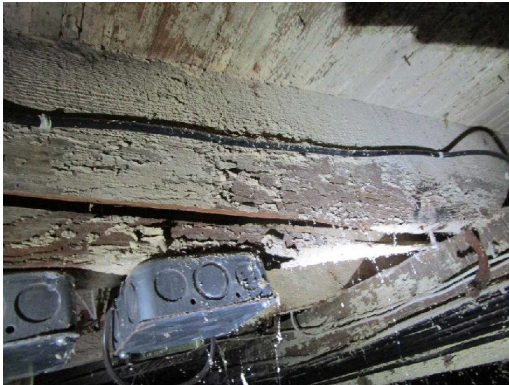
7. ☐☐☐☐☒ Electrical: 110 VAC - NOTICED: /1. Secure wiring. /2. No electricity during inspection.
ACTION: /A licensed electrician must repair PRIOR to limitation set forth by the contract.

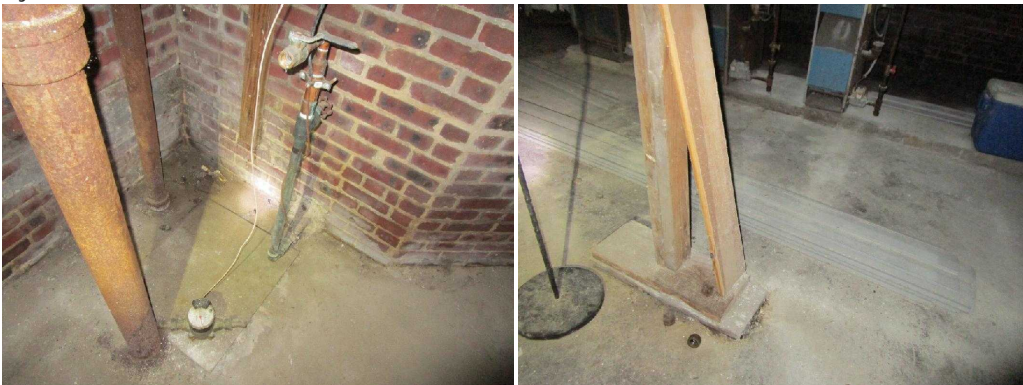
7. ☐ ☐ ☐ ☐ ☒ Piers/Posts: Lally Columns - NOTICED: /1. Lally columns rusted at the bottom. /2. Wood post without footing.
ACTION: /A structural engineer MUST evaluate and estimate repairs PRIOR to limitations set forth by the contract.

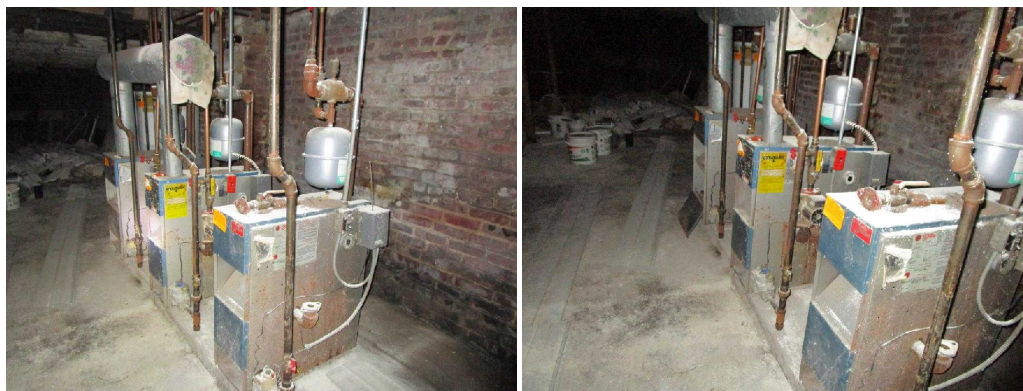
1. ☐ ☐ ☐ ☐ ☒ Heating System Operation: Inoperative - NOTICED: /1. Boilers to be replaced. /2. Excessive rust noticed.
ACTION: /1. replacement required PRIOR to limitation set forth by the contract /2. Since there is no chimney in place, direct appliances can be installed
2. Manufacturer: Utica

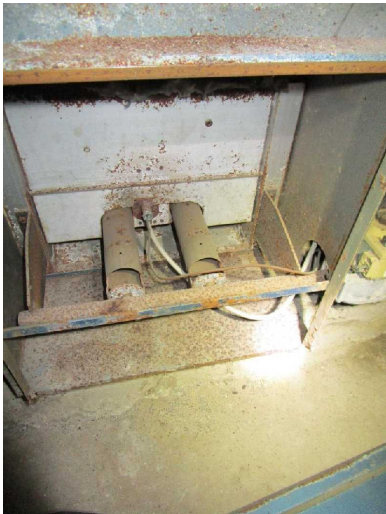
6. ☐☐☐☒ Heat Exchanger: 2 Burner - NOTICED: /1. Evidence of burning. /2. Excessive rust.
ACTION: /boiler replacement REQUIRED

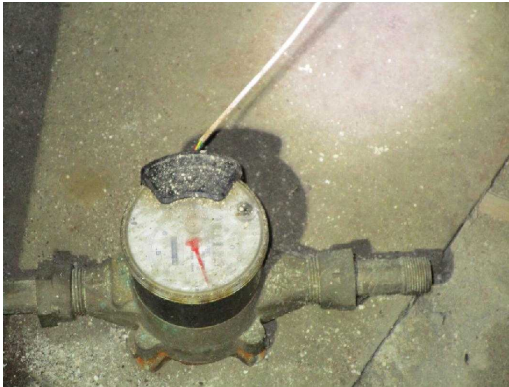
34. Main Water Shutoff: Basement - NOTICED: /1. Excessive rust noticed. /2. Main water service disconnected.

ACTION: /A licensed plumber must evaluate and estimate repairs PRIOR to limitation set forth by the contract,

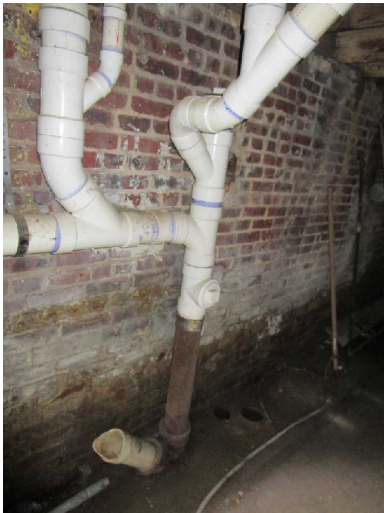
36. Drain Pipes: Cast iron - NOTICED: /1. Major plumbing issues on sewer stack. /2. Cast iron to be replaced for PVC.

ACTION: /1. Main sewer stack to be replaced for PVC /2. Inspect with a camera the entire sewer system PRIOR to closing. /3.Also, contact town's building department to determine if this home has a public sewer or a septic system to handle waste water

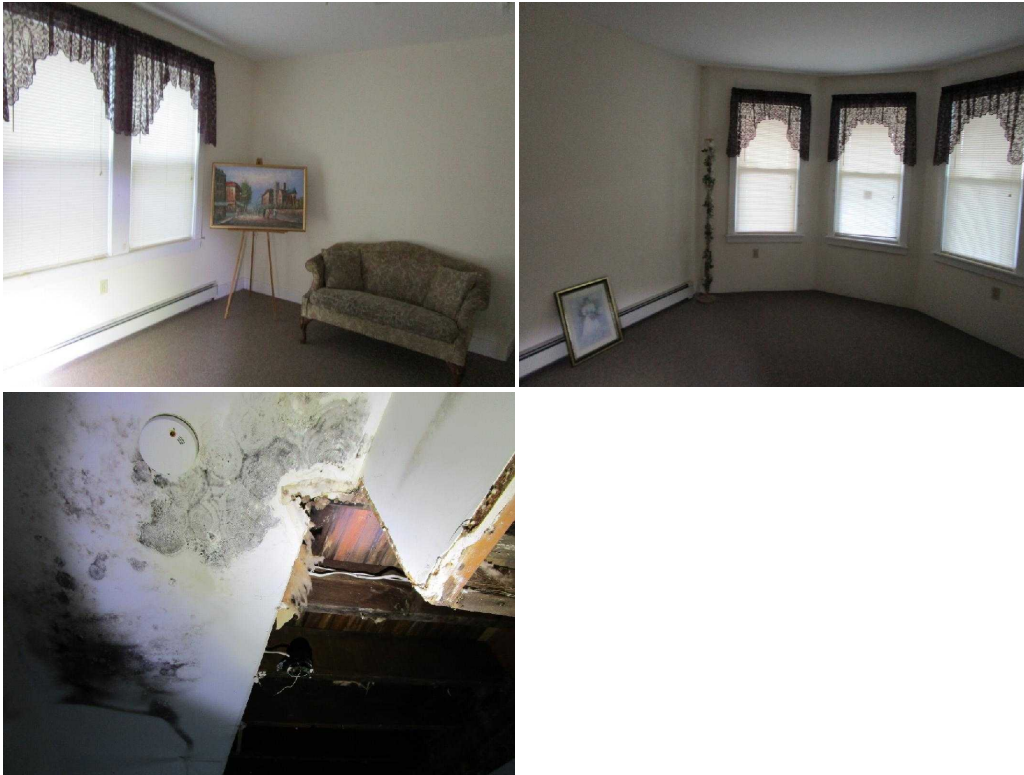
1. ☐☐☐☐☒ Ceiling: Finished - NOTICED: /1. Major interior water damaged in walls and ceiling. /2. Appears to be mold

ACTION: /A registered general contractor MUST evaluate and estimate repairs PRIOR to limitation set forth by the contract.

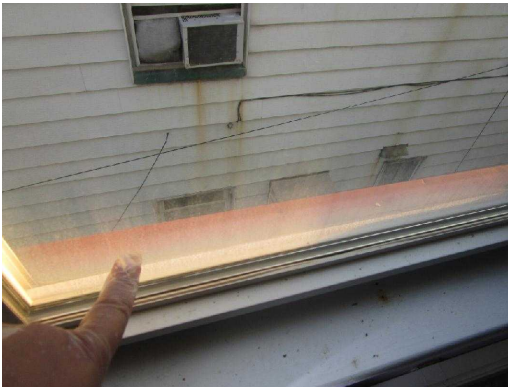
12. ☐ ☐ ☐ ☐ ☒ Windows: Vinyl - NOTICED: /Window has fogging between the layers of glass.

ACTION: /A registered general contractor must evaluate and estimate repairs PRIOR to limitations set forth by the contract.

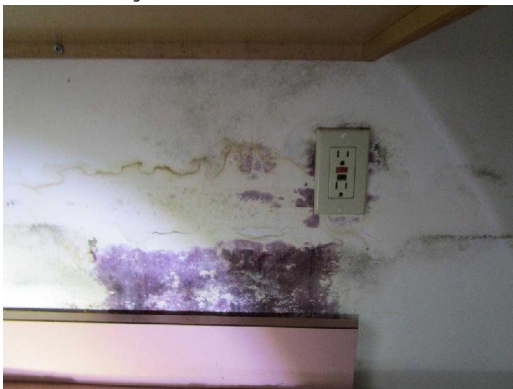
15. ☒☐☐☐☐ Walls: Finished walls - NOTICED: /1. Major interior water damaged in walls and ceiling. /2. Appears to be mold
ACTION: /A registered general contractor MUST evaluate and estimate repairs PRIOR to limitation set forth by the contract.

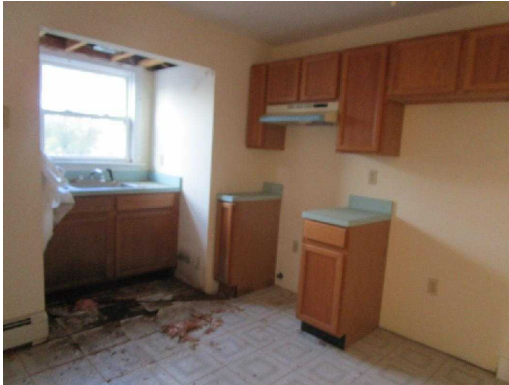
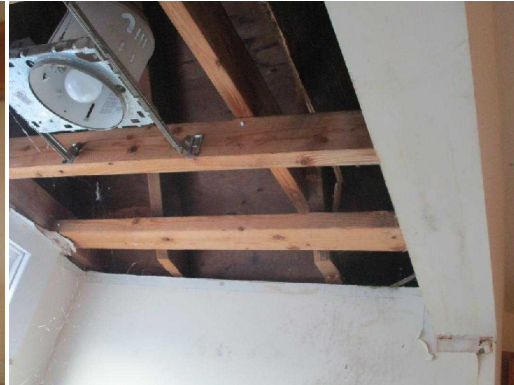
49. ☐☐☒☐☐ Plumbing/Fixtures: Sink fixtures - NOTICED: /Unable to test due to water being shut off to house.
Recommend having water service turned on and have qualified plumbing contractor certify function
50. ☒☐☐☐☐ Counter Tops: Fair
51. ☒☐☐☐☐ Cabinets: Wood
52. ☐☒☐☐☐ Pantry: None
53. ☐☐☐☐☒ Ceiling: Finished - NOTICED: /1. Major interior water damaged in walls and ceiling. /2. Appears to be mold
ACTION: /A registered general contractor MUST evaluate and estimate repairs PRIOR to limitation set forth by the contract.

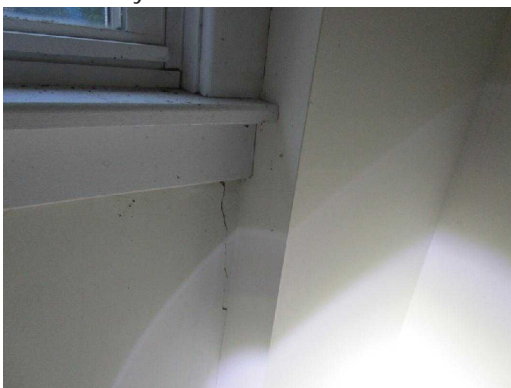
2. ☐☐☐☐☒ Walls: Finished walls - NOTICED: /Crack noticed near window.
ACTION: /A registered general contractor MUST evaluate and estimate repairs PRIOR to limitation set forth by the contract.

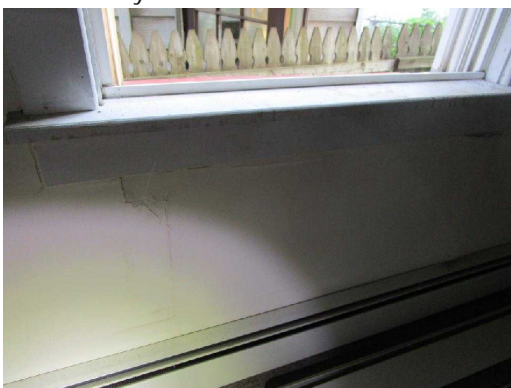
3. ☐☐☐☐☒ Walls: Finished walls - NOTICED: /Crack noticed near window.
ACTION: /A registered general contractor MUST evaluate and estimate repairs PRIOR to limitation set forth by the contract.

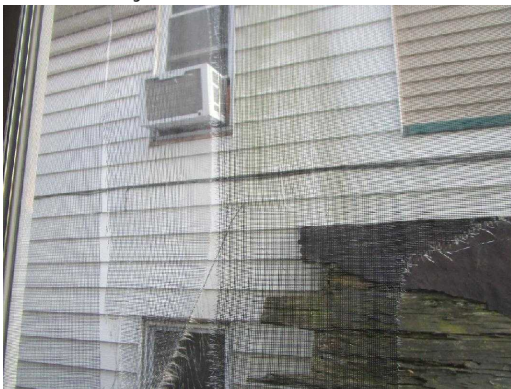
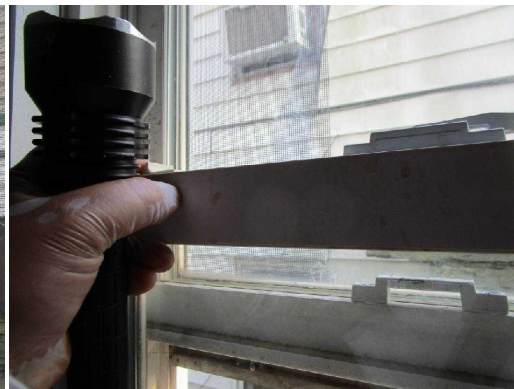
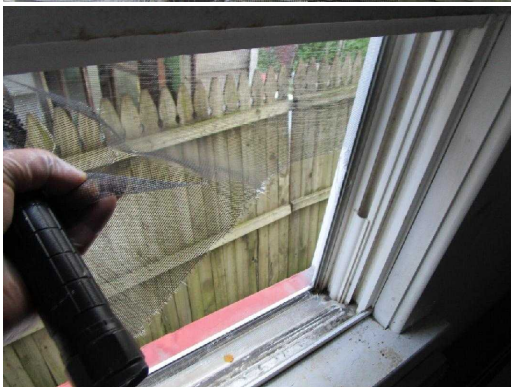
5. ☒☐☐☐☐ Doors: Hollow wood
6. ☐☐☐☐☒ Windows: Repair prior to closing - NOTICED: /1. Torn window screen. /2. Difficult operation.
ACTION: /A registered general contractor must evaluate and estimate repairs PRIOR to limitations set forth by the contract.

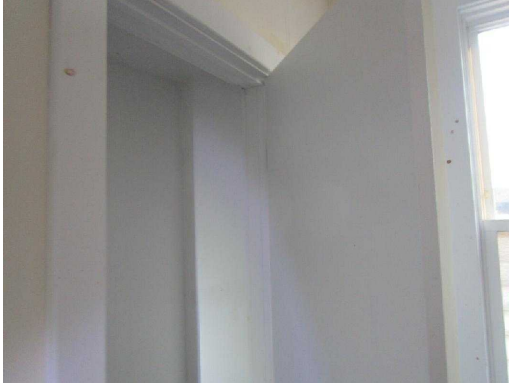
9. ☐☐☐☒☐ Closet: Single - NOTICED: /Missing clothes rod on closets

ACTION: /A registered general contractor MUST evaluate and estimate repairs PRIOR to limitation set forth by the contract.

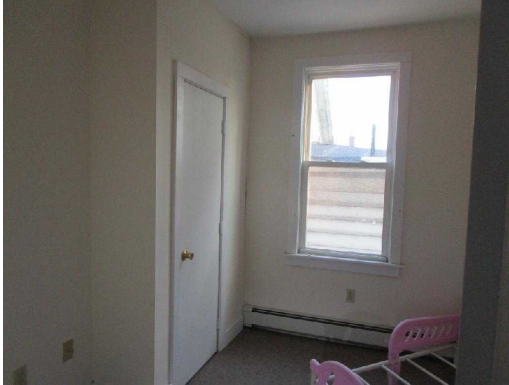
12. ☐ ☐ ☐ ☐ ☒ Floor: Carpet - NOTICED: /1. Major carpet. /2. Floor damages at some bedrooms.
ACTION: /A registered general contractor MUST evaluate and estimate repairs PRIOR to limitation set forth by the contract.

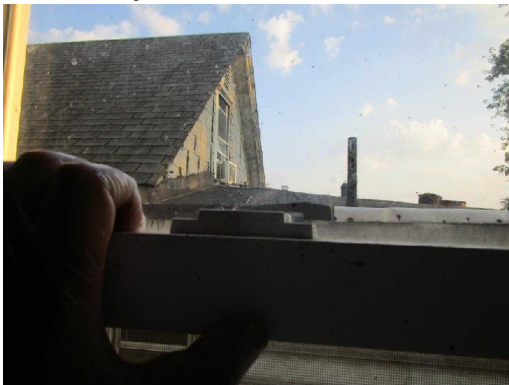
14. ☐ ☐ ☐ ☐ ☒ Windows: Vinyl - NOTICED: /Difficult operation.

ACTION: /A registered general contractor must evaluate and estimate repairs PRIOR to limitations set forth by the contract.
